The RV Refrigerator

Rebuild or Replace?

- Leon Herschberger
- National RV Refrigeration

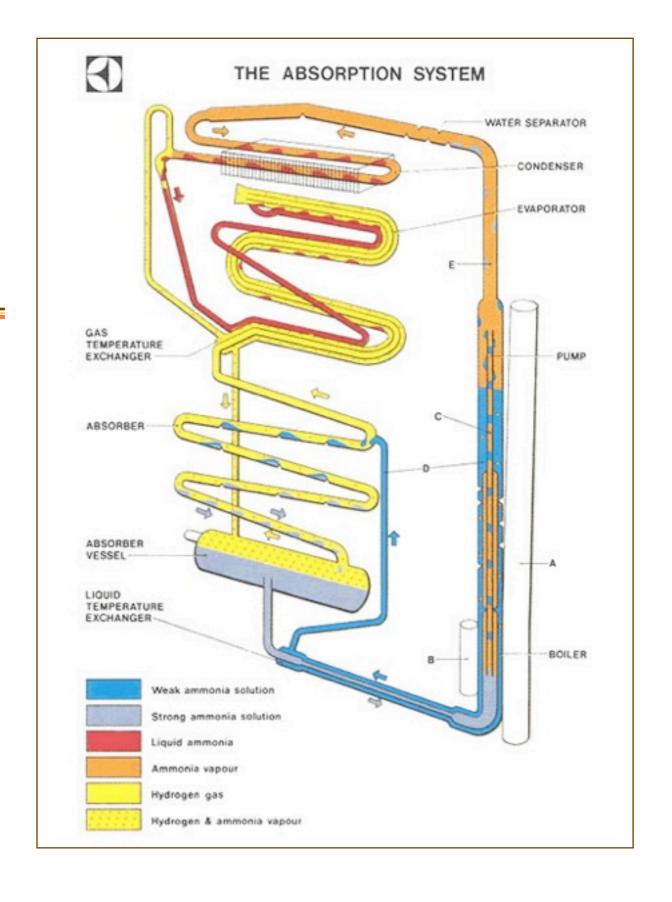
Continuous Absorption Cooling Unit

- Four Components
 - Boiler
 - Condenser
 - Evaporator
 - Absorber

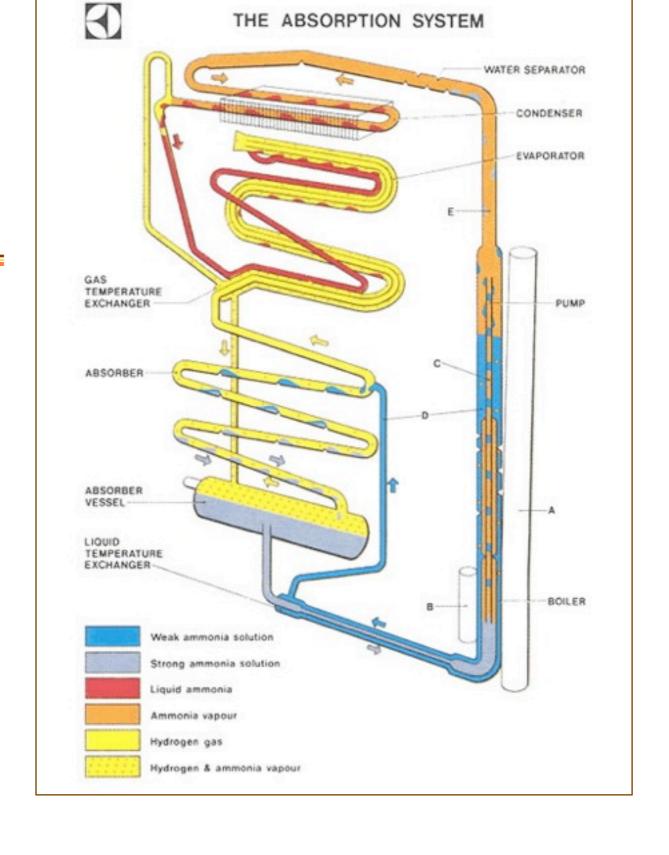
The Unit Charge

- Quantities of...
 - Ammonia
 - Water
 - Hydrogen
- Pressure condenses ammonia at room temperature

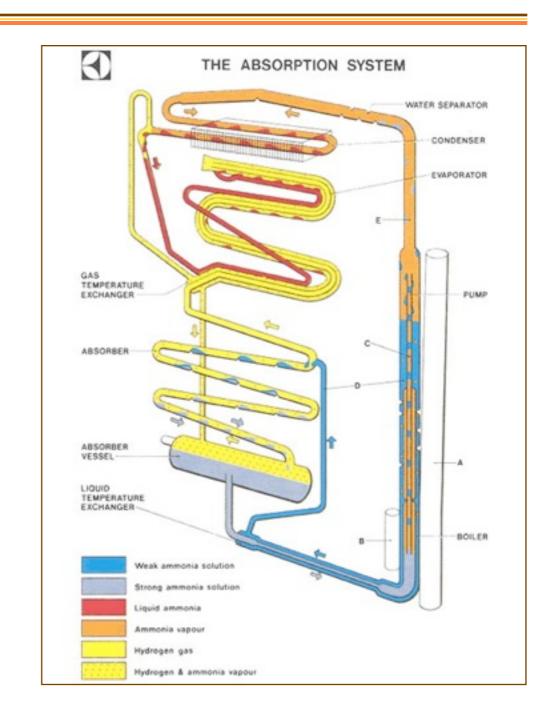
- Heat vaporizes ammonia
- Fins cool ammonia vapor
- Condenses into liquid
- Flows to evaporator
- Evaporator supplied with hydrogen
- Hydrogen evaporates liquid ammonia
- Evaporation of ammonia extracts heat from food storage space

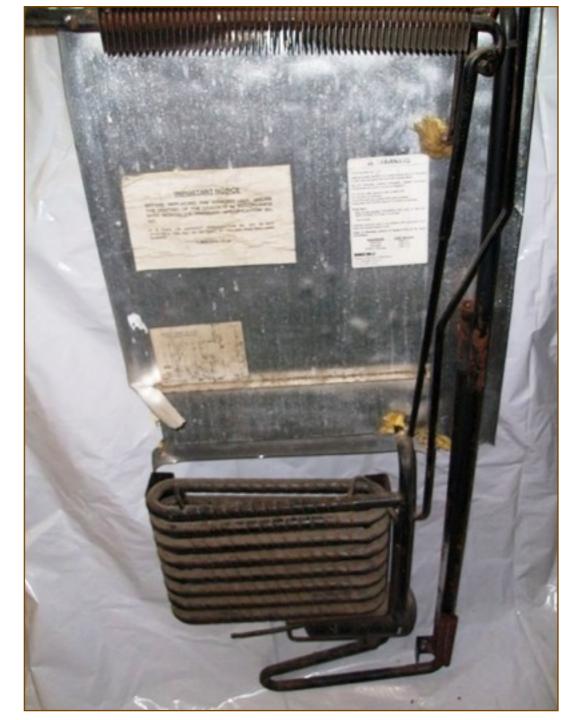
1: Assess the Unit

- The cooling unit before start
- Fits a Norcold 6 cu.ft. refrigerator
- Has some visible rust but in good condition otherwise
- 14 years old, has quit cooling

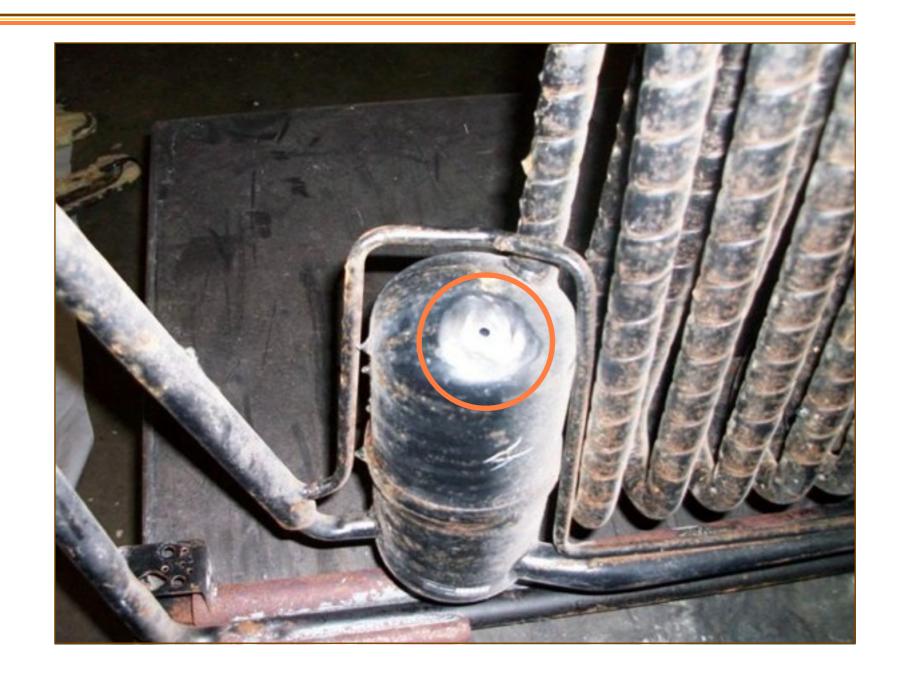
2: Cut Off Stem - Ouch!

- On all Norcold refrigerator units – no charge port, just a stem welded shut
- Cut off stem and replace with new charge port

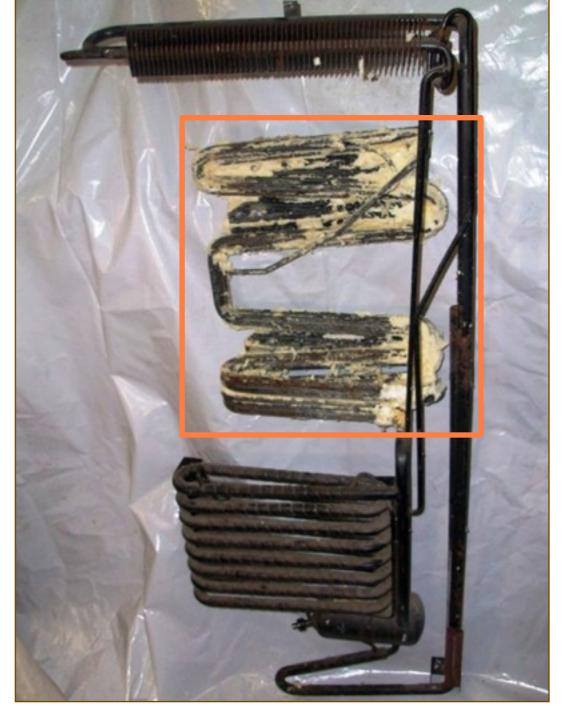
4: Remove Foam to Examine Evaporator

- Foam pack removed
- Evaporator coils checked for damage

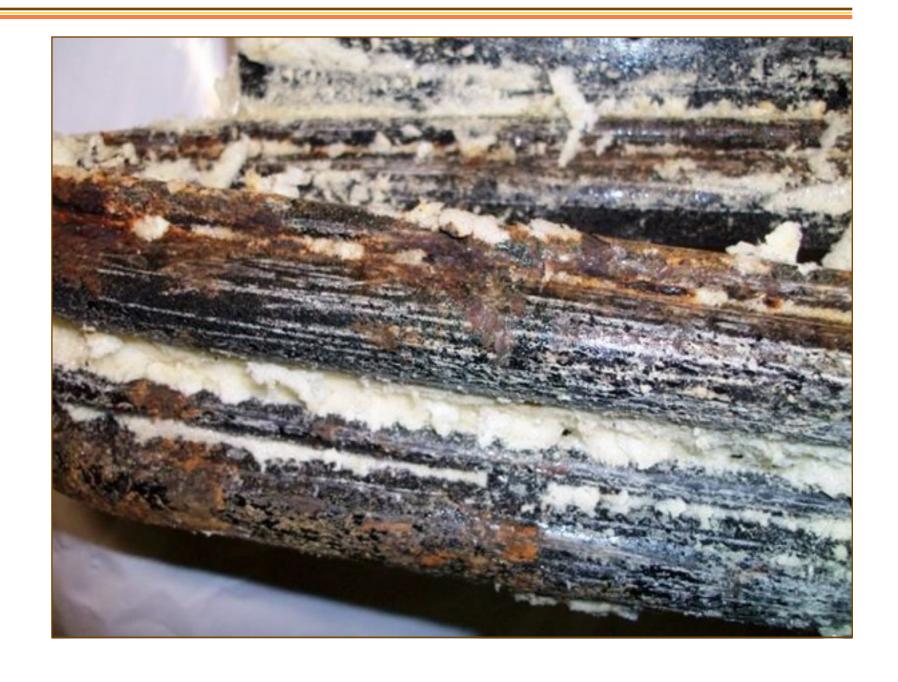
5: Determine Damage

• Here you can see...
the cooling unit has extensive rust damage inside the foam though it looked good outside

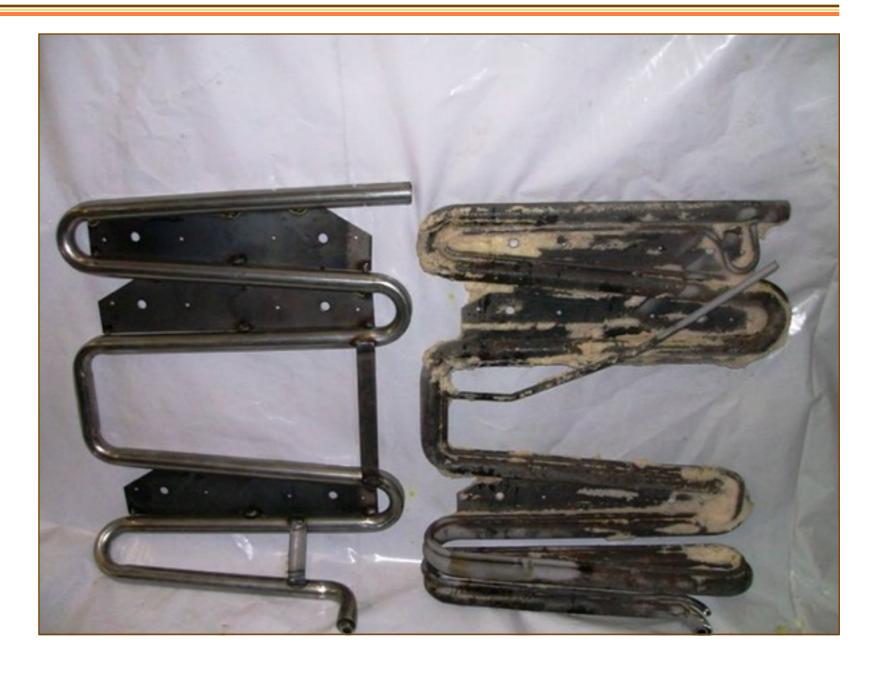
Comparing Old and New Evaporator

Old and new evaporator side by side

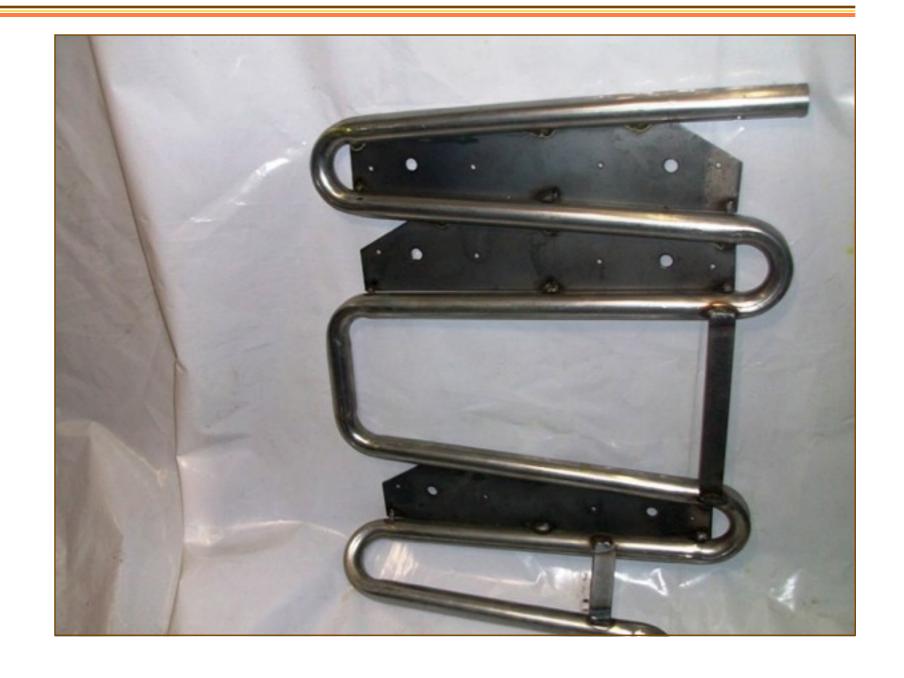
New Evaporators In Stock

New parts are made ahead and kept in stock
